Analysis of lightning current distribution in lightning protection system and connected installation

Abstract. The aim of this paper was to analyze lightning current distribution in a typical lightning protection system (LPS) and connected supplying electrical installation. Some preliminary tests done in 2012 for the real scale test house model equipped with the LPS and connected to the 15kV/400V supplying transformer station showed that the most of the current flew through the transformer grounding. Moreover, shapes of the current wave-forms in the LPS grounding rods were different from the surge, and strongly dependent of the transformer grounding characteristics. In order to make precise analysis a simple model of the LPS was prepared at the open test site. The model was a frame consisted of rectangular air terminals and two grounding rods. Transformer circuit was connected to the one side of the frame near the ground surface. The lightning stroke current was injected to the frame with application of 10/15 μ s stroke generator of energy about 10 kJ. Measurement was done for several different configurations of the LPS, and for current amplitudes varied from 100 A up to 3 kA. The

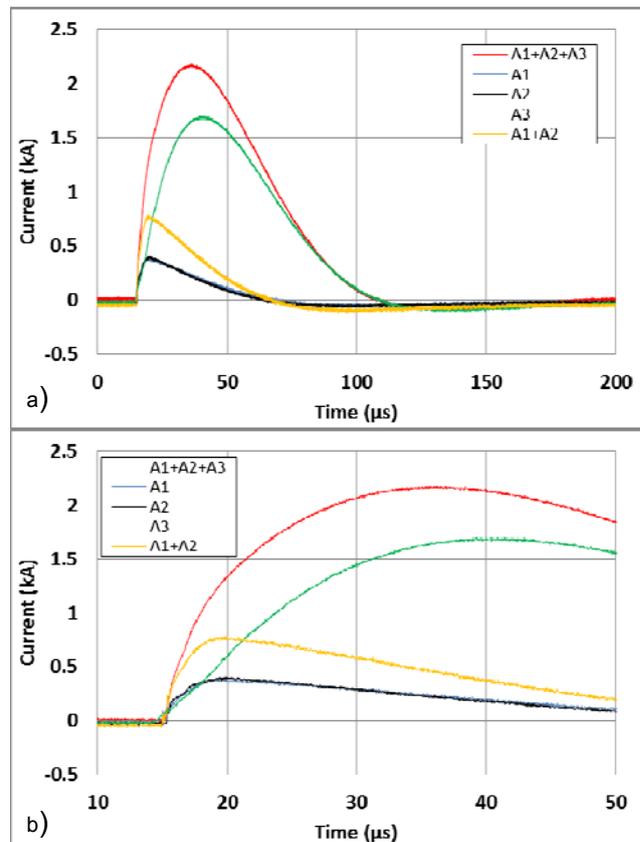
Fig. 4. Distribution of the current in the frame and supplying installation (Fig. 1) for 30 kV from the generator. Notice that in case of Figs. 4 to 7 the only difference between a) and b) is time scale.

Measurement, regarding the configuration from Fig. 1, was done in order to check general distribution of the generator current in the model of LPS and supplying transformer circuit. The results for 30 kV and 40 kV from the generator were presented in Figs. 4 and 5. Currents observed in both cases were similar to those recorded previously for the real LPS installed at the test house. It confirmed that the frame was good representation of the real installation. Moreover, the measured resistances of the particular rods were close to those obtained for the test house model. Comparing amplitudes of currents the performance of this part of the LPS consisted of grounding rods was poor. Most of the surge current flew through the PEN wire of the isolated cable to the transformer grounding. The ratio of the transformer current and rods current was approximately 2.14 while theoretically, on the basis of measured resistances, it should be 3.21. This relatively high difference was because only resistance was taken into account. There is necessity to measure impedance parameters of groundings. In the future this kind of measurement is planned with application of MZ-407 manufactured at the Gdansk University of Technology, Poland [5]. Different impedance character of the particular elements of the system was observed for all recordings. Current peaks were reached at different moments of time. In case of grounding rods the rising times were short which correspond to the higher frequency components. On the other hand the content of lower frequency was greater for

relatively low resistive transformer grounding. The reason was probably an influence of the inductance of the long cable connection between the LPS and transformer grounding. This is particularly important for the lightning surges where the content of higher frequency components might be significant. In case of the direct discharge into LPS, faster components dissipate in the protected area, while the rest of the lightning current flow to the supplying station. The flow of fast components to the ground might be dangerous for systems located in the building, even not physically connected to the electrical installation. The electromagnetic fields and capacitive coupling might be the source of overvoltages induced in the electrical appliances located near the air terminals.

Comparing Figs. 4 and 5, currents are almost the same regarding shape and amplitude ratio between waveforms. The impedance character of particular elements remained un-changed during the tests. No nonlinearities were observed in this case. The highest current amplitude was about 3 kA which is not enough to initiate ground discharges. Further tests with generators of greater energies and for circuits of lower impedance are planned in order to check the influence of this phenomena on lightning current distribution.

Therefore, the following analysis was based on the results presented in Figs. 4 and 5. For this configuration resistances of particular rods were about 45 Ω which is four times lower than for the frame from Fig. 6. In order to make comparison with currents obtained for the frame, in Figs. 4 and 5 an additional type of the waveform, A1+A2, was introduced. It gave information about current in the frame loop. The ratio of the sum A1+A2 and generator current was about 30 % and was independent of the surge amplitude. The same ratio was only 10 % for results presented in Fig. 6. The shape of waveforms gave more information about the character of phenomena observed in the LPS. In each case the maximum of the grounding rod current occurred during the rise of the generator current. For only one shape of the generator impulse, it is difficult to state that the waveforms A1 and A2 are dependent on the surge derivative. Tests with application of different impulses are needed to make reliable analysis and verify physical relationships.

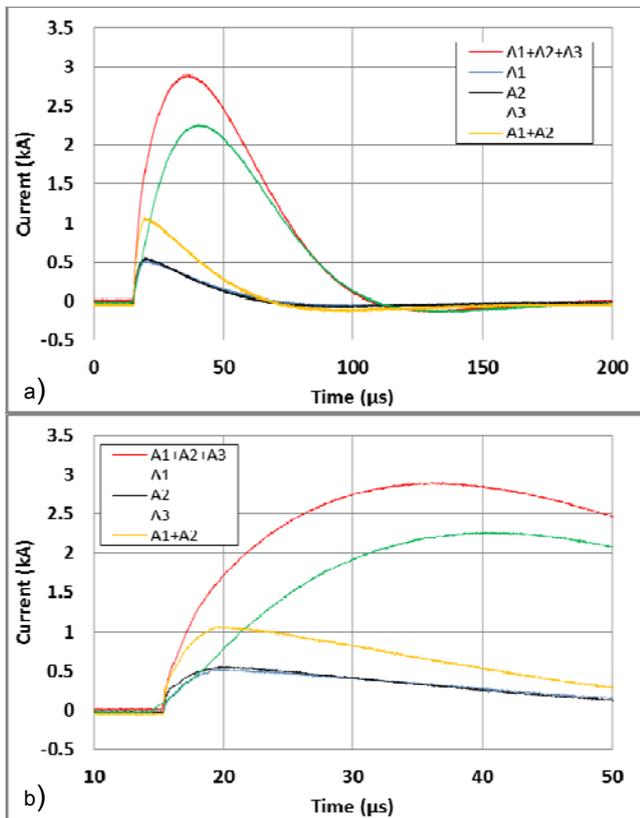
Fig. 5. Distribution of the current for the same configuration as in Fig. 4. for 40 kV from generator.

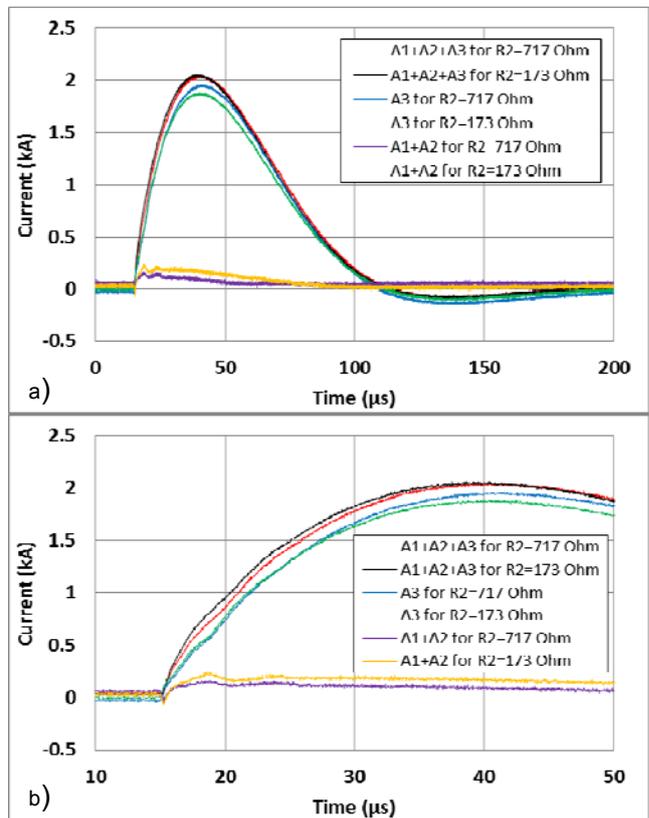
Fig. 6. Comparison of selected currents for different depths of R2 grounding rod. In the first configuration R1=160 Ω ; R2=717 Ω ; Rtrafo=6.28 Ω . For the second arrangement where R2 was buried deeper R1=164 Ω ; R2=173 Ω ; Rtrafo= 6.28 Ω .

was to verify previous research obtained with application of the oscilloscope and BNC wired connections. During the research done in Camp Blanding and Rzeszow, for some configurations of LPS, the current amplitude observed in grounding rods was higher than the surge. Authors suggested that the reason might be the inductance of the frame composed of air terminals, grounding rods and soil. The difference of the grounding resistance between rods and supplying circuit grounding forced the current to flow mainly to the transformer through only one side of the air terminal. The asymmetrical distribution of the current at the frame gave resultant inductance stream through the frame surface. Self-inductance was the reason of the additional current induced in the frame. The second possibility of the current amplitude increase, suggested on the basis of the re-research done at the campus of Rzeszow University of Technology, was influence of measuring setup. Especially BNC connections between the shunt and oscilloscope were taken into account. In the paper both hypotheses were under verification. The most recent results were shown in Fig. 6. Firstly, R2 was at depth of only 15 cm. The measured grounding resistance was 717 Ω , respectively.

The relatively high grounding resistance R2 was selected to force current to flow to the transformer grounding. Unfortunately, the effect of the amplitude increase was not observed in the case. The ratio between R2 and transformer grounding resistance was oversized. The waveforms for R1 and R2 were not recorded due to sensitivity of the measuring setup. Only the sum of currents to grounding rods was computed from the generator and transformer waveform. The most of the current flew through two sides of the frame and dissipated in the transformer grounding. The asymmetry of the current was strong but the mentioned effect was not appeared. The resistance in the frame loop was too high which prevented induced current to flow. The only possibility was to decrease the resistance by deeper position of grounding rods.

In the second case R2 was at full depth of 1.5 m, and only 173 Ω was measured for this configuration. However, the result was similar. The ratio of the transformer and frame grounding resistances was still too high to observe induced current. Moreover, currents were too low to exceed measuring system trigger level. There was no option for further resistance decrease with application of the single grounding rod.

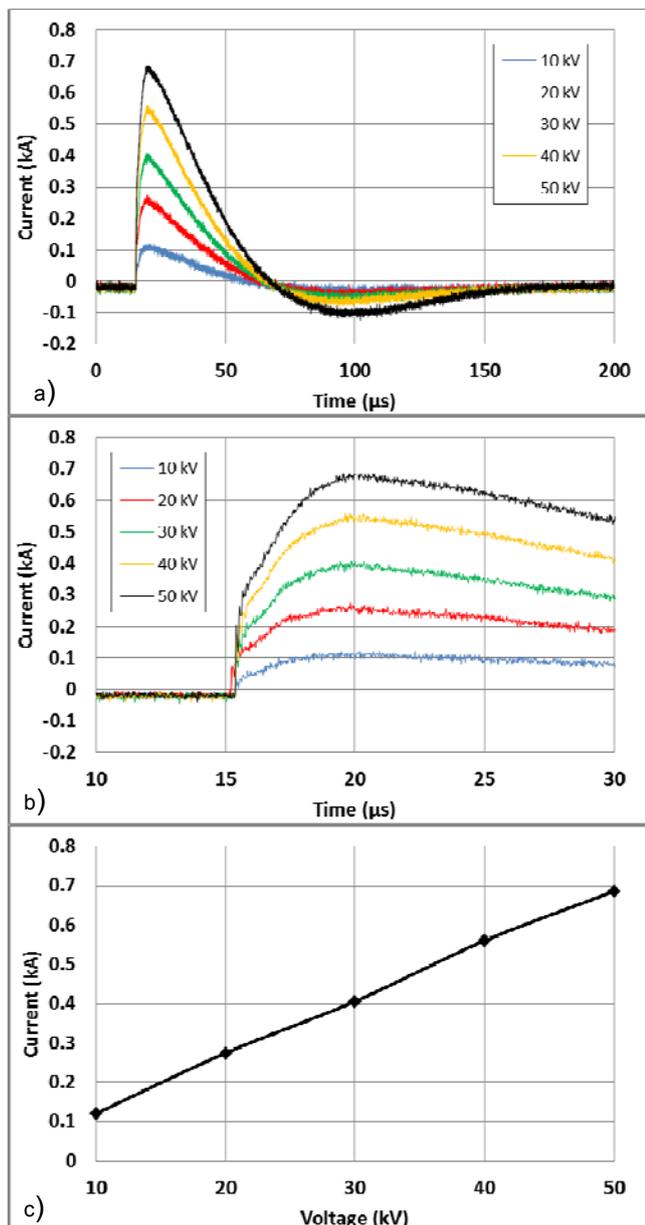
Fig. 7. Current in R2 grounding rod for different amplitudes of surges from the generator – a,b). Influence of the surge generator voltage on the maximum of the current in R2 grounding – c). Notice: system configuration and grounding resistances of frame as for Fig. 4.

An additional analysis of the influence of the voltage applied from the generator was done. The result was presented in Fig. 7. Except the amplitude, an interesting conclusion from Fig. 7 was that the shapes of particular waveforms were similar each other. The peaks were reached directly at the same time independently of the generator voltage amplitude. The analysis proved that the amplitude of the current in the grounding rod is proportional to the surge amplitude.
