Measurements of electric disturbances in low voltage installations inside rooms near the high voltage laboratory

Abstract. The paper is aimed to measurements of electric disturbances in low voltage installations inside rooms near the high voltage laboratory during its work. The high voltage laboratory is a part of Faculty of Electrical Engineering Warsaw University of Technology building and is placed close to other rooms, like library, classrooms or another laboratories. During measurements has been carried out a study to establish connection between the observed interference and high voltage laboratory work.

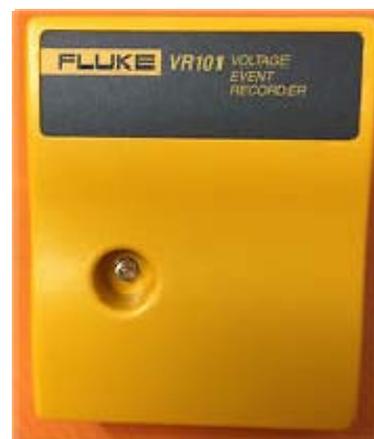
Fig. 2. FLUKE VR101S Event Recorder

In each of these locations has been installed device for monitoring supply voltage condition and recording the situation where the supply voltage parameters have been exceeded and time of their occurrence. As the research monitoring and recording device FLUKE VR101S Event Recorder with Event View 2.16 software, shown in Fig. 2, was used.

Its configuration parameters defining the levels of disorders that cause its activation are as follows:

- Line to neutral thresholds:
 - swell voltage – 256 V
 - sag voltage – 210 V
 - transient deviation – 200 V
- Neutral to ground thresholds:
 - swell voltage – 10 V
 - transient deviation – 100 V
- Frequency thresholds:
 - minimum – 48,8 Hz
 - maximum – 51,2 Hz

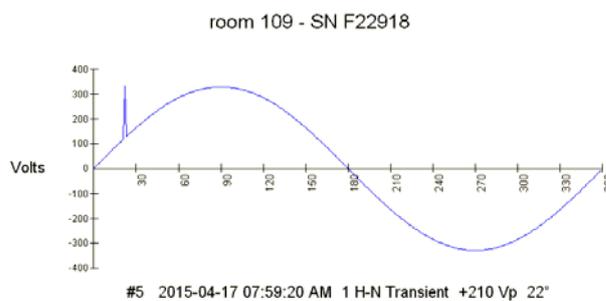
As we can observe the most frequent events were transient type. Its measured maximum value was about 400 V with duration about 10 μ s. Exemplary record is presented in fig. 3.

Fig. 3. Exemplary recording of transient event.

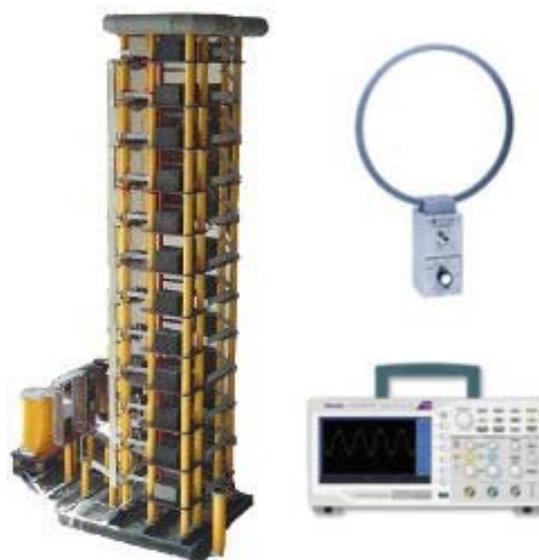
Fig. 4. High voltage surge generator 2.4 MV, passive loop antenna EMCO model 6509 and oscilloscope Tektronix TBS1052-EDU.

As a source of high voltage was used high voltage surge generator with maximum voltage level 2.4 MV, but for test it was reduced to 1 MV. Voltage measurement was performed with Tektronix TBS1052B-EDU oscilloscope equipped with attenuator. For electromagnetic field measurement was used EMCO 6509 passive loop antenna. All measurement equipment is presented on fig. 4. This antenna had four switchable measuring ranges: 0,001-0,06 MHz; 0,06-0,4 MHz; 0,4-1 MHz; 1-30 MHz.

This test relies on generating high voltage surge with maximum voltage level 1 MV and parallel observations of its effect on the power supply voltage and electromagnetic field in considered rooms.
